TRENCHLESS TECHNOLOGY RESOURCE CENTRE	
	TRENCHLESS TECHNOLOGY GUIDELINES	SECOND EDITION
	MANHOLE REHABILITATION TECHNIQUES	NEW VERSION SEPTEMBER 2005

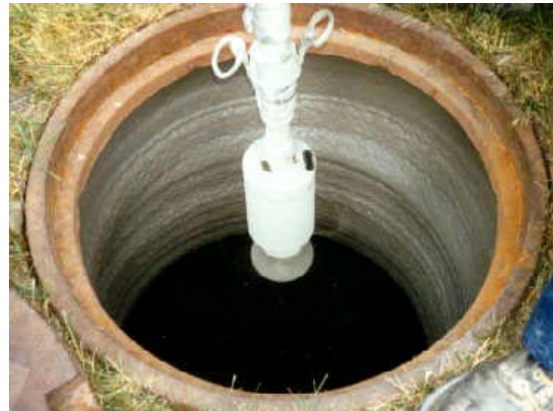
Spray lining of a manhole with a specially designed spray nozzle.

Here a manhole is first cleaned to remove debris and to create a bonding surface for the sprayed compound product to adhere to. A special spray nozzle (various systems are available to the market) is then utilised to apply a grout product to the inner wall of the manhole. The product may be cementitious or polymer based depending on the criteria required of the lining, the preferred choice of the client and the final product requirements in terms of operating conditions expected. The spray system can be designed to be applied in as thick a coating as required. Many of the systems available may require a level of manhole pre-treatment if infiltration is high simply to prevent washout of the spray coating before curing is complete by stopping inflows (see above).

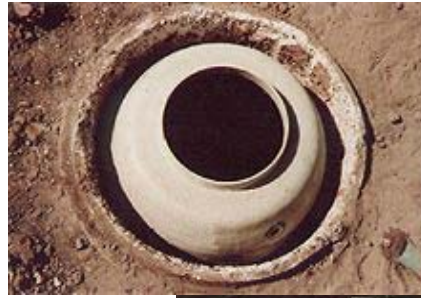
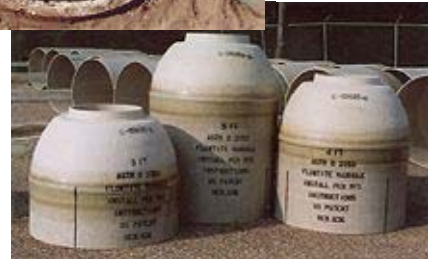
<A liner inserted into an existing manhole.

Preformed Manhole liners.>
Picture courtesy of Containment Solutions Inc

Preformed Sections: This type of lining, as in mainline sewer rehabilitation, comprises the use of factory-built units, either of standard dimensions or specially constructed design to the measured dimensions of the manholes under rehabilitation. Sections can be of concrete or plastic but are more usually designed from Glass-reinforced concrete (GRC) or Glass-reinforced plastic (GRP). The sections are usually designed in single monolithic sections that are positioned within the manhole structure. Once in place the annulus between the new liner and the existing manhole wall is grout filled to form the permanent bond between liner and existing manhole, making the new lining an integral part of the manhole and so part of the structural integrity. Standard units are available for manhole depths from 0.9 m to 7.5 m, and with inside diameters from 1,066 mm to 1,830 mm. Manufacturers can supply non-standard units on request.

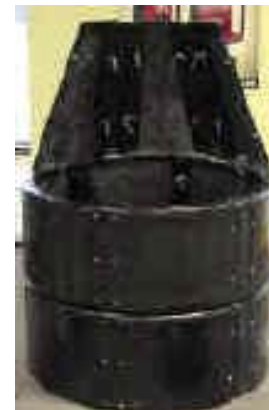
A typical manhole rehabilitation former, shown in a manhole above left. Picture courtesy of Improved Construction Methods.

Poured-in-Place: Poured-in-place systems are very much self-explanatory, in that what it says is what you get. The technology relies on the placing, in the manhole to be rehabilitated, a former to the shape and size of the required lining. The former can be of either steel or plastic material and is available in a variety of standard sizes depending on the manufacturer used. They can also be custom-made to specified dimensions. With the former in the manhole concrete is poured

around it, often using vibration to ensure the concrete settles correctly and fully fills the former's annulus. Once the concrete is full to the top of the former it is allowed to cure according to the concrete curing specification.

Once cured the former is removed from the manhole to leave the new liner in place. If a plastic inner wall liner is required as a final product in the manhole it is also possible to design a plastic skin that is placed around the outer surface of the former during its construction. The design allows for the plastic to anchor into the concrete as it is poured, so creating an integrated concrete/plastic liner within the manhole.

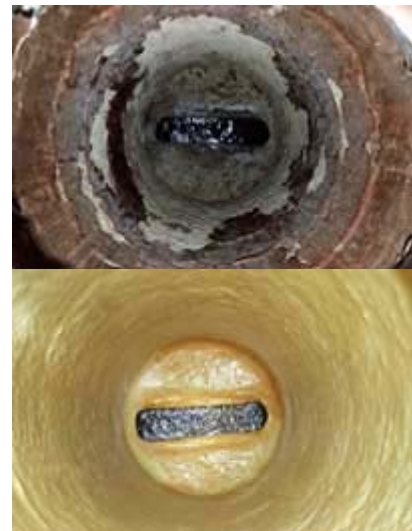
CIPP manhole rehabilitation before (top) and after (bottom). *Pictures courtesy of Poly-Triplex.*

With the product fabric chosen, the liner is inserted into the manhole under repair from the top of the manhole. Once in the manhole the liner is 'inflated' using a flexible bladder that is itself inflated with compressed air. This pushes the liner against the existing manhole wall where it is allowed to cure. Once cured, the bladder is deflated and removed leaving the liner in place.

Once cured, the liner is cut in the relevant places to reopen lateral connections should there be any and to open the base inlets and outlets.
